**DEPARTMENT OF TRANSPORTATION****DIVISION OF ENGINEERING SERVICES**

Office of Structural Materials

Quality Assurance and Source Inspection

Contract #: 04-0120F4Cty: SF/ALA Rte: 80 PM: 13.2/13.9File #: 69.15**SOURCE INSPECTION REPORT****Resident Engineer:**Pursell, Gary**Address:** 333 Burma Road**City:** Oakland, CA 94607**Report No:** SIR-000538**Date Inspected:** 12-Apr-2009**Project Name:** SAS Superstructure**OSM Arrival Time:** 0**Prime Contractor:** American Bridge/Fluor Enterprises, a JV**OSM Departure Time:** 12**Contractor:** Zhenhua Port Machinery Company, Ltd (ZPMC), Changxing Island **Location:** Changxing Dao, Shanghai

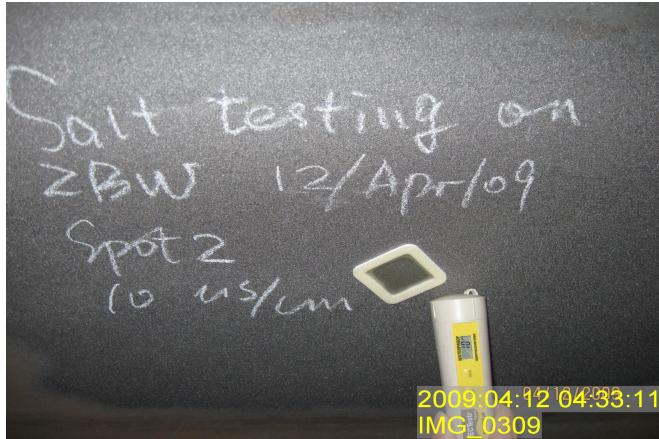
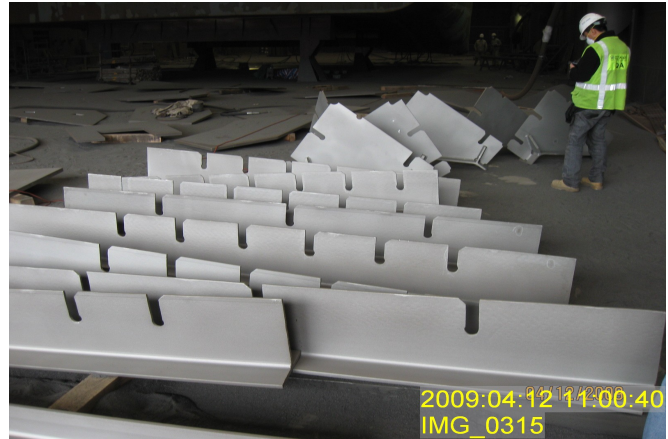
Temporary Tower

6 splices were abrasive blasted and primed.
